PROPERTY REPORT

HOMEOWNER EXAMPLE

Kansas City, Missouri | Property address withheld

Installer coordination edition | Contractor condition, causation and next-step review. Field investigation pending.

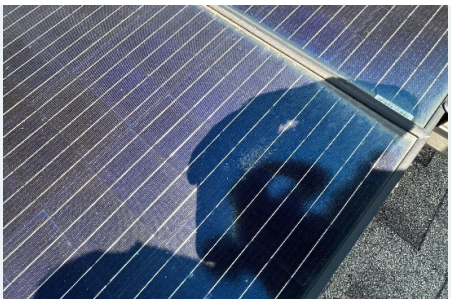
NORTH KANSAS CITY AREA

Reported hail: 1.25 inches at 1 NW, 1.50 inches at 1 SSE and 1.75 inches at 2 SE. These reports anchor a regional event window; they do not measure hail size at this parcel or establish roof damage. [S1-S2]
